LDW
OSM
JF Outfall
(eml)
02/10/2016

From: Dyer, Miles <mdyer@JorgensenForge.com>
Sent: Wednesday, February 10, 2016 3:36 PM
To: Sanga, Ravi
Cc: William D. Ernst
Subject: RE: JFO - Sheetpile probing - Downslope Face
Attachments: Sheet piles and Inner pockets N to S2.pdf

From: Paul Grant [mailto:pgrant@pangeoinc.com]
Sent: Wednesday, February 10, 2016 3:17 PM
To: William D. Ernst; Dyer, Miles; Colligan, Tom ; Daniel Balbiani; Dee Gardner
Subject: JFO - Sheetpile probing - Downslope Face

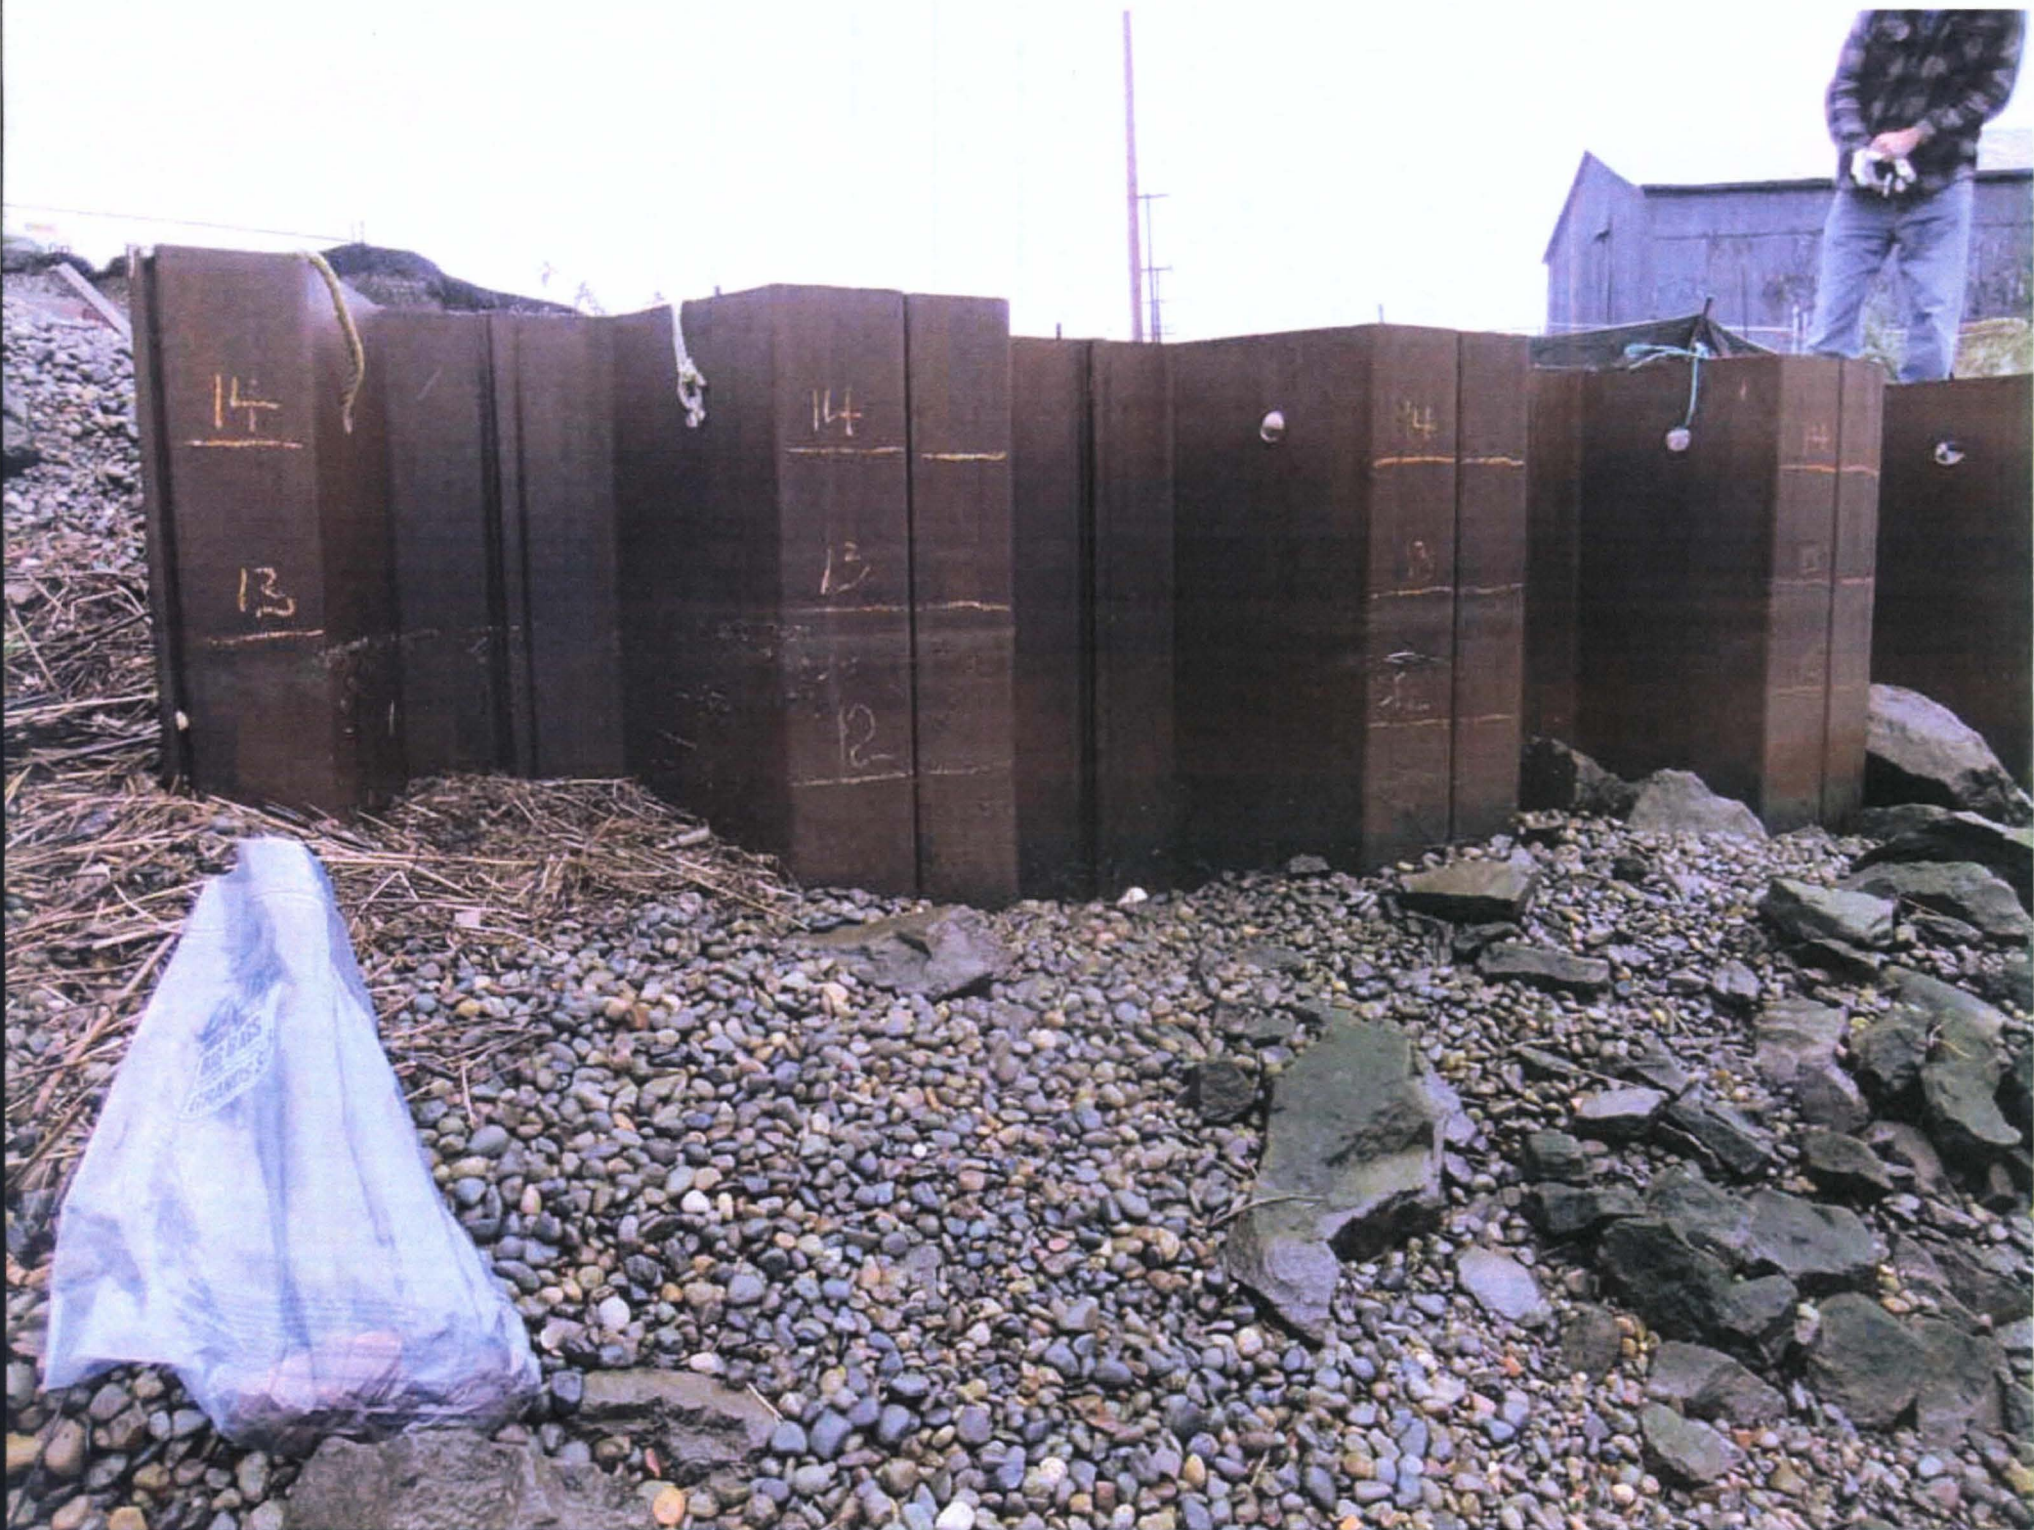
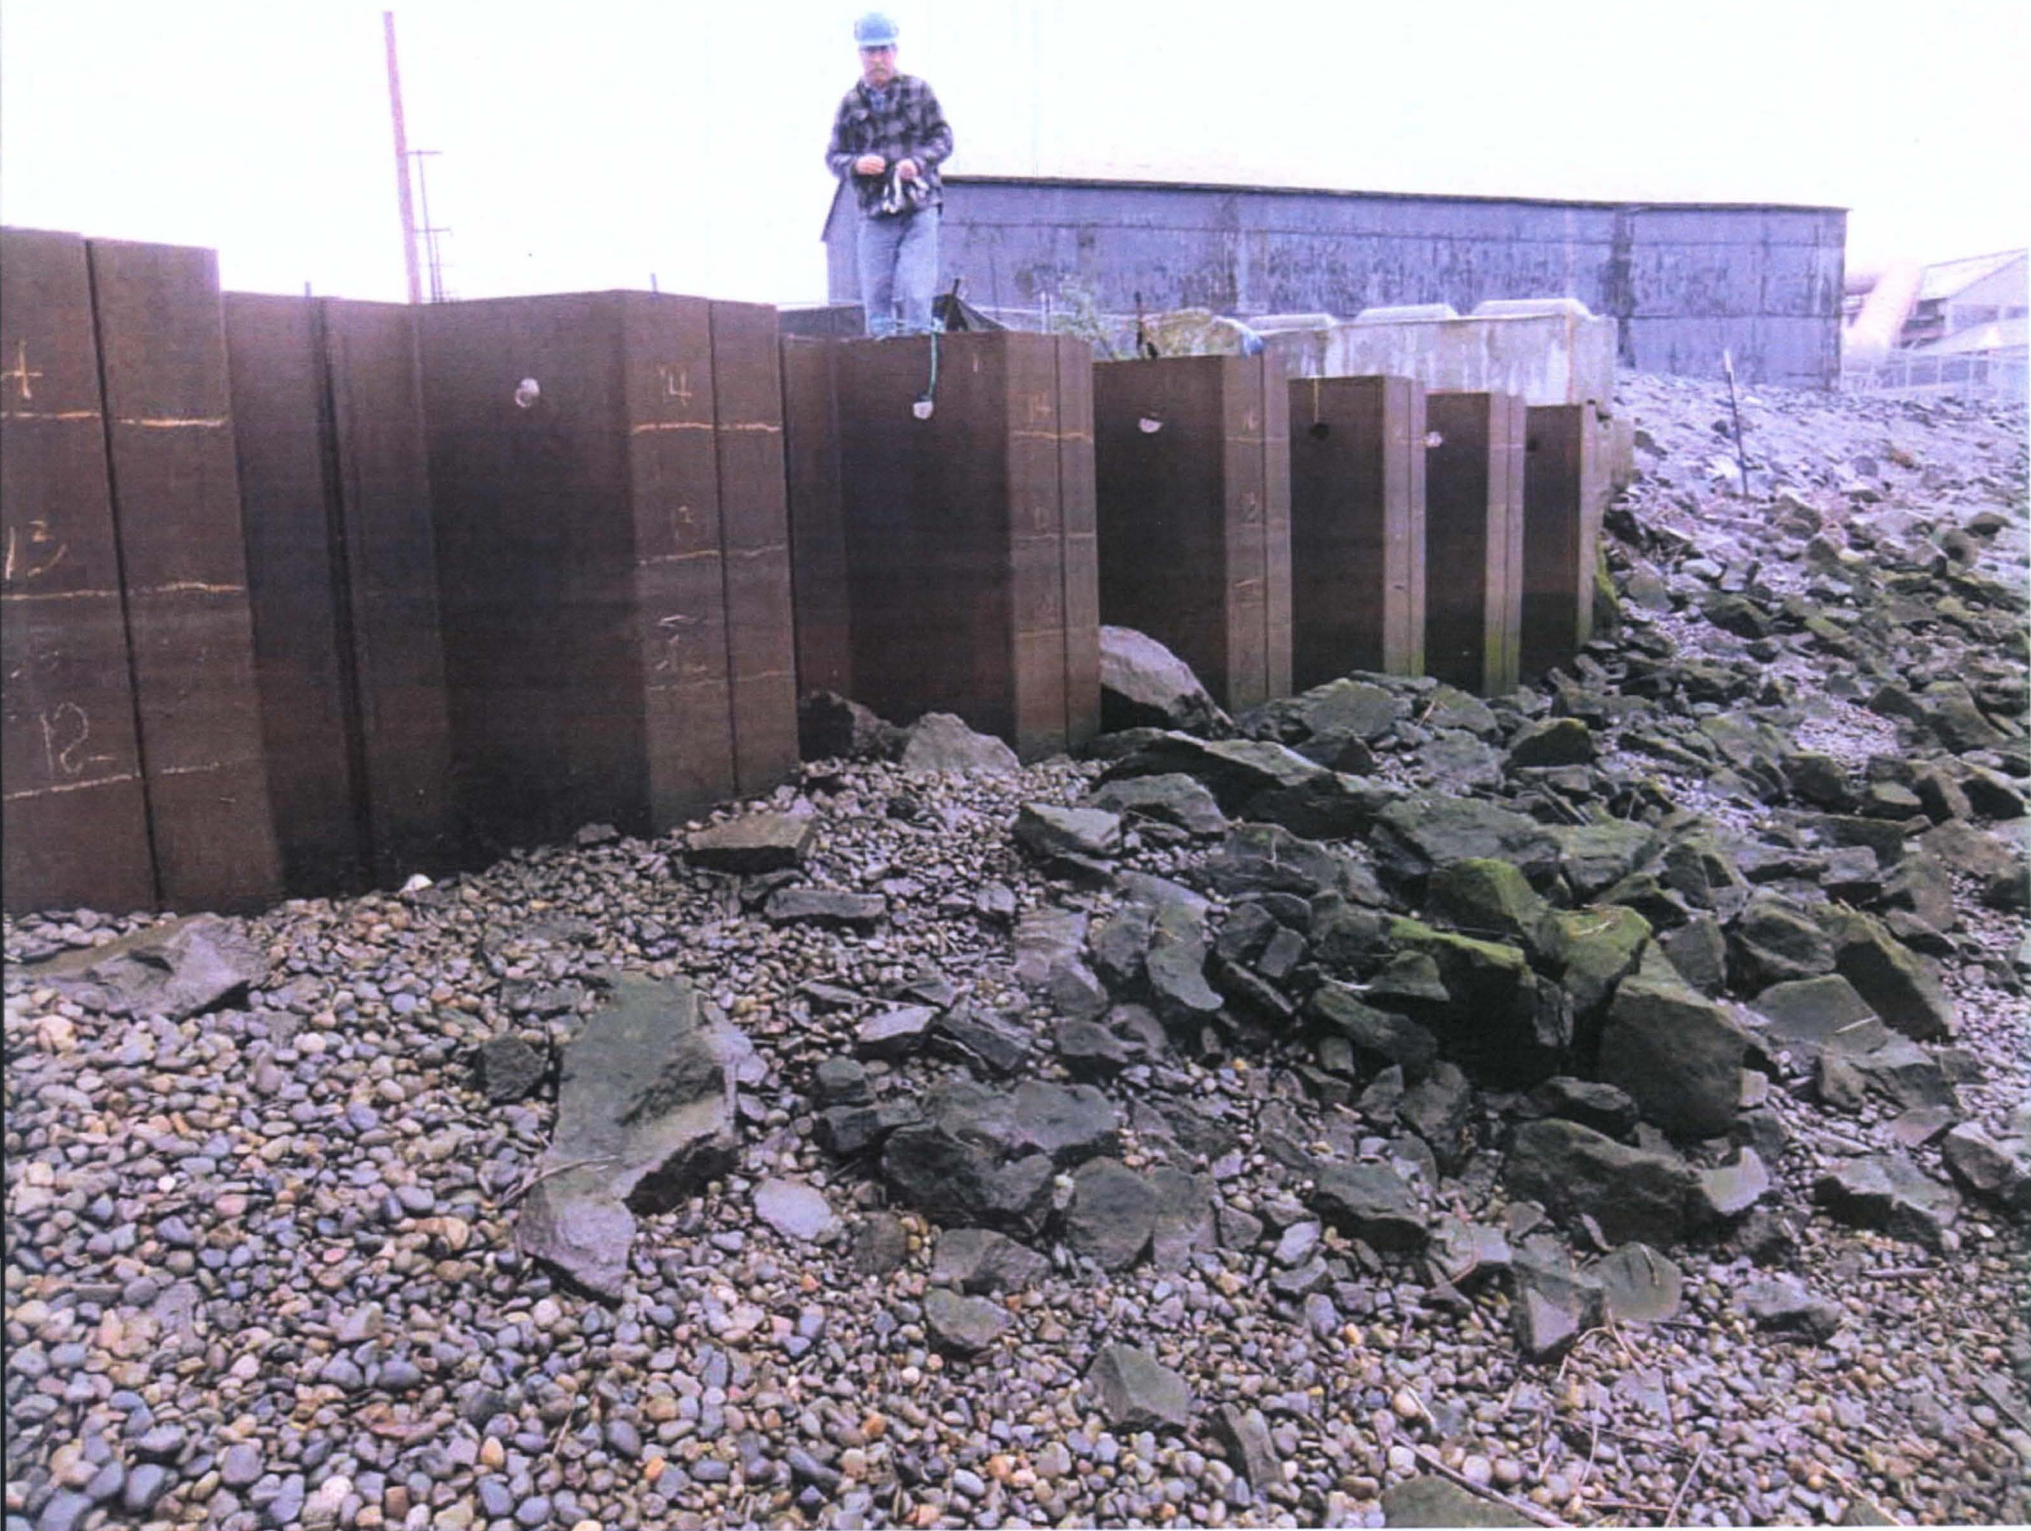
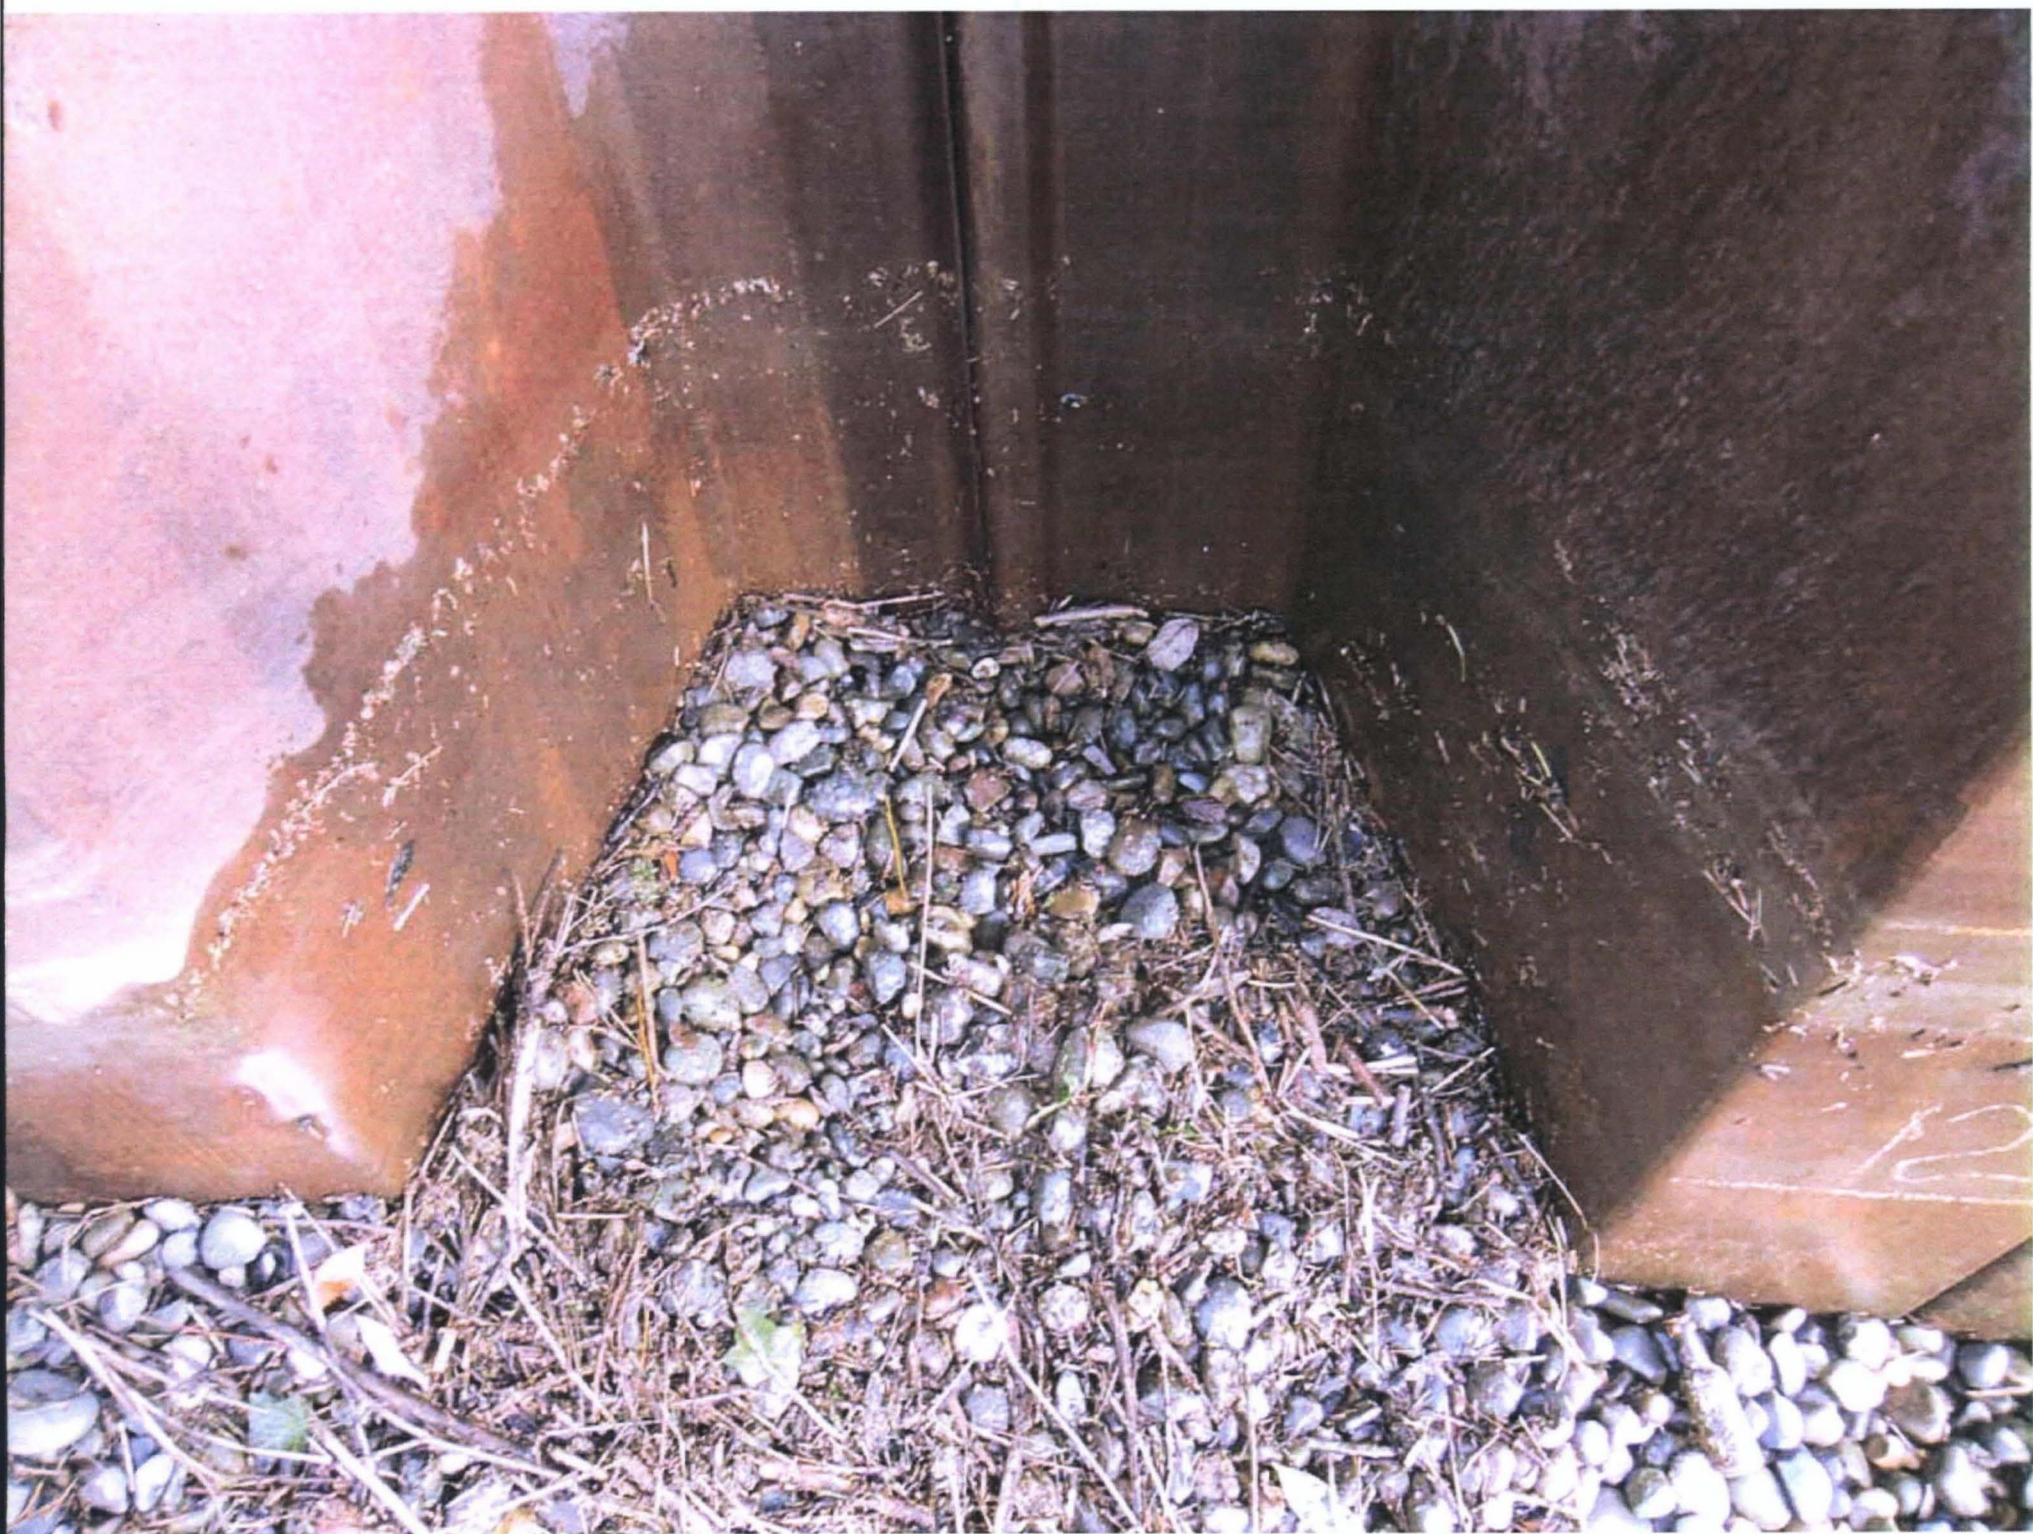
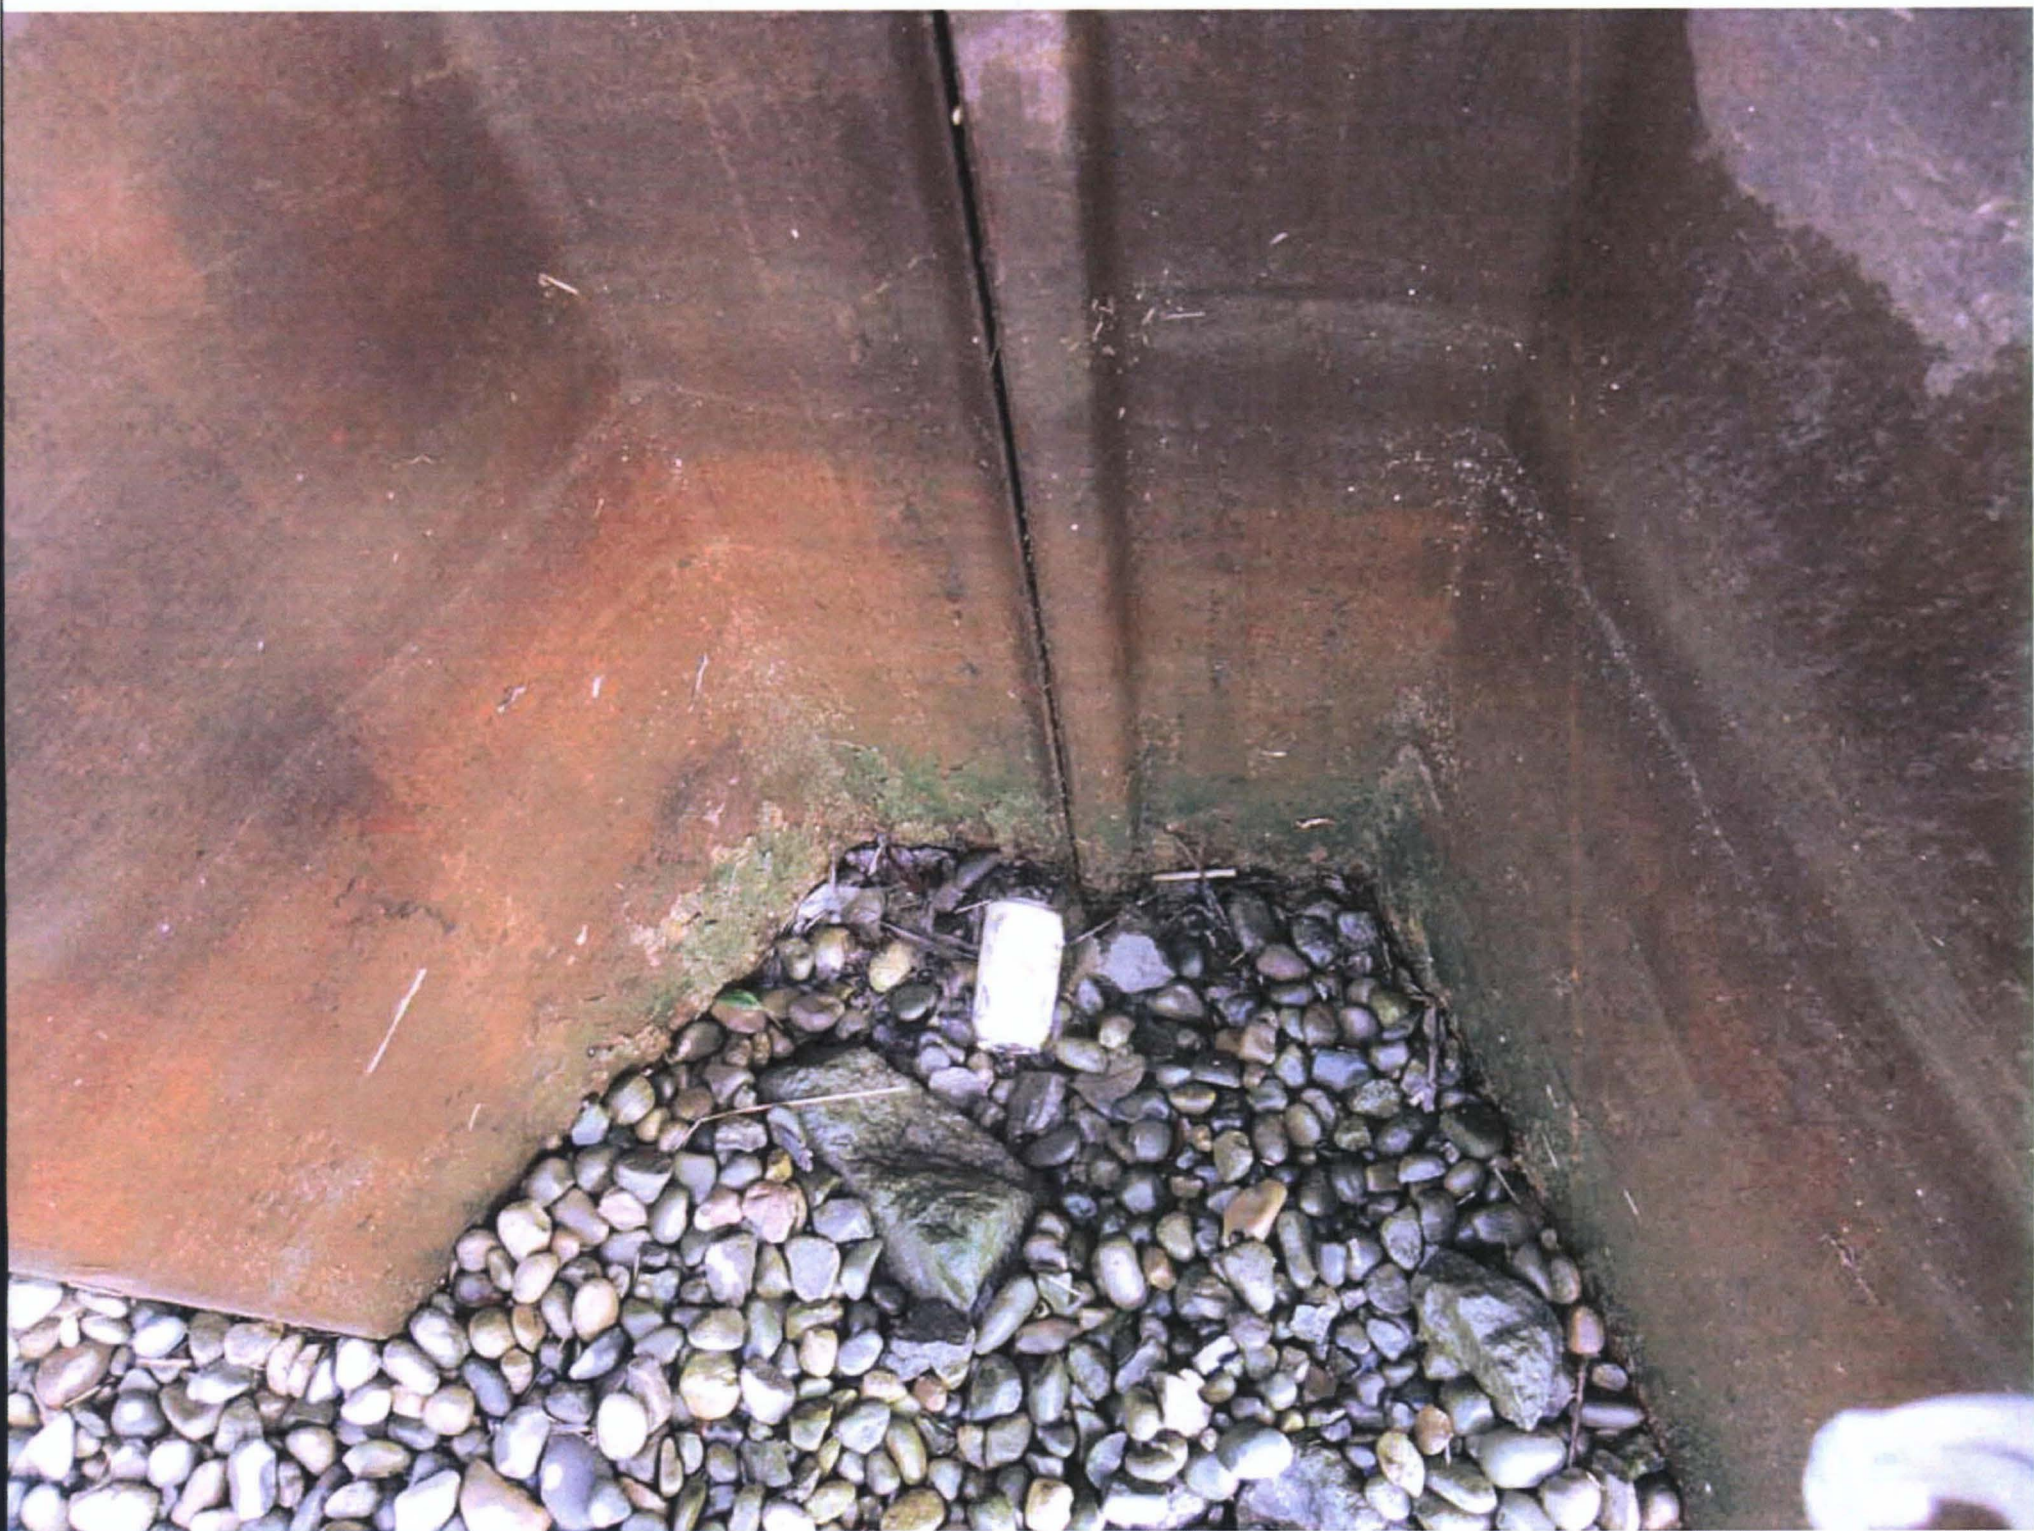
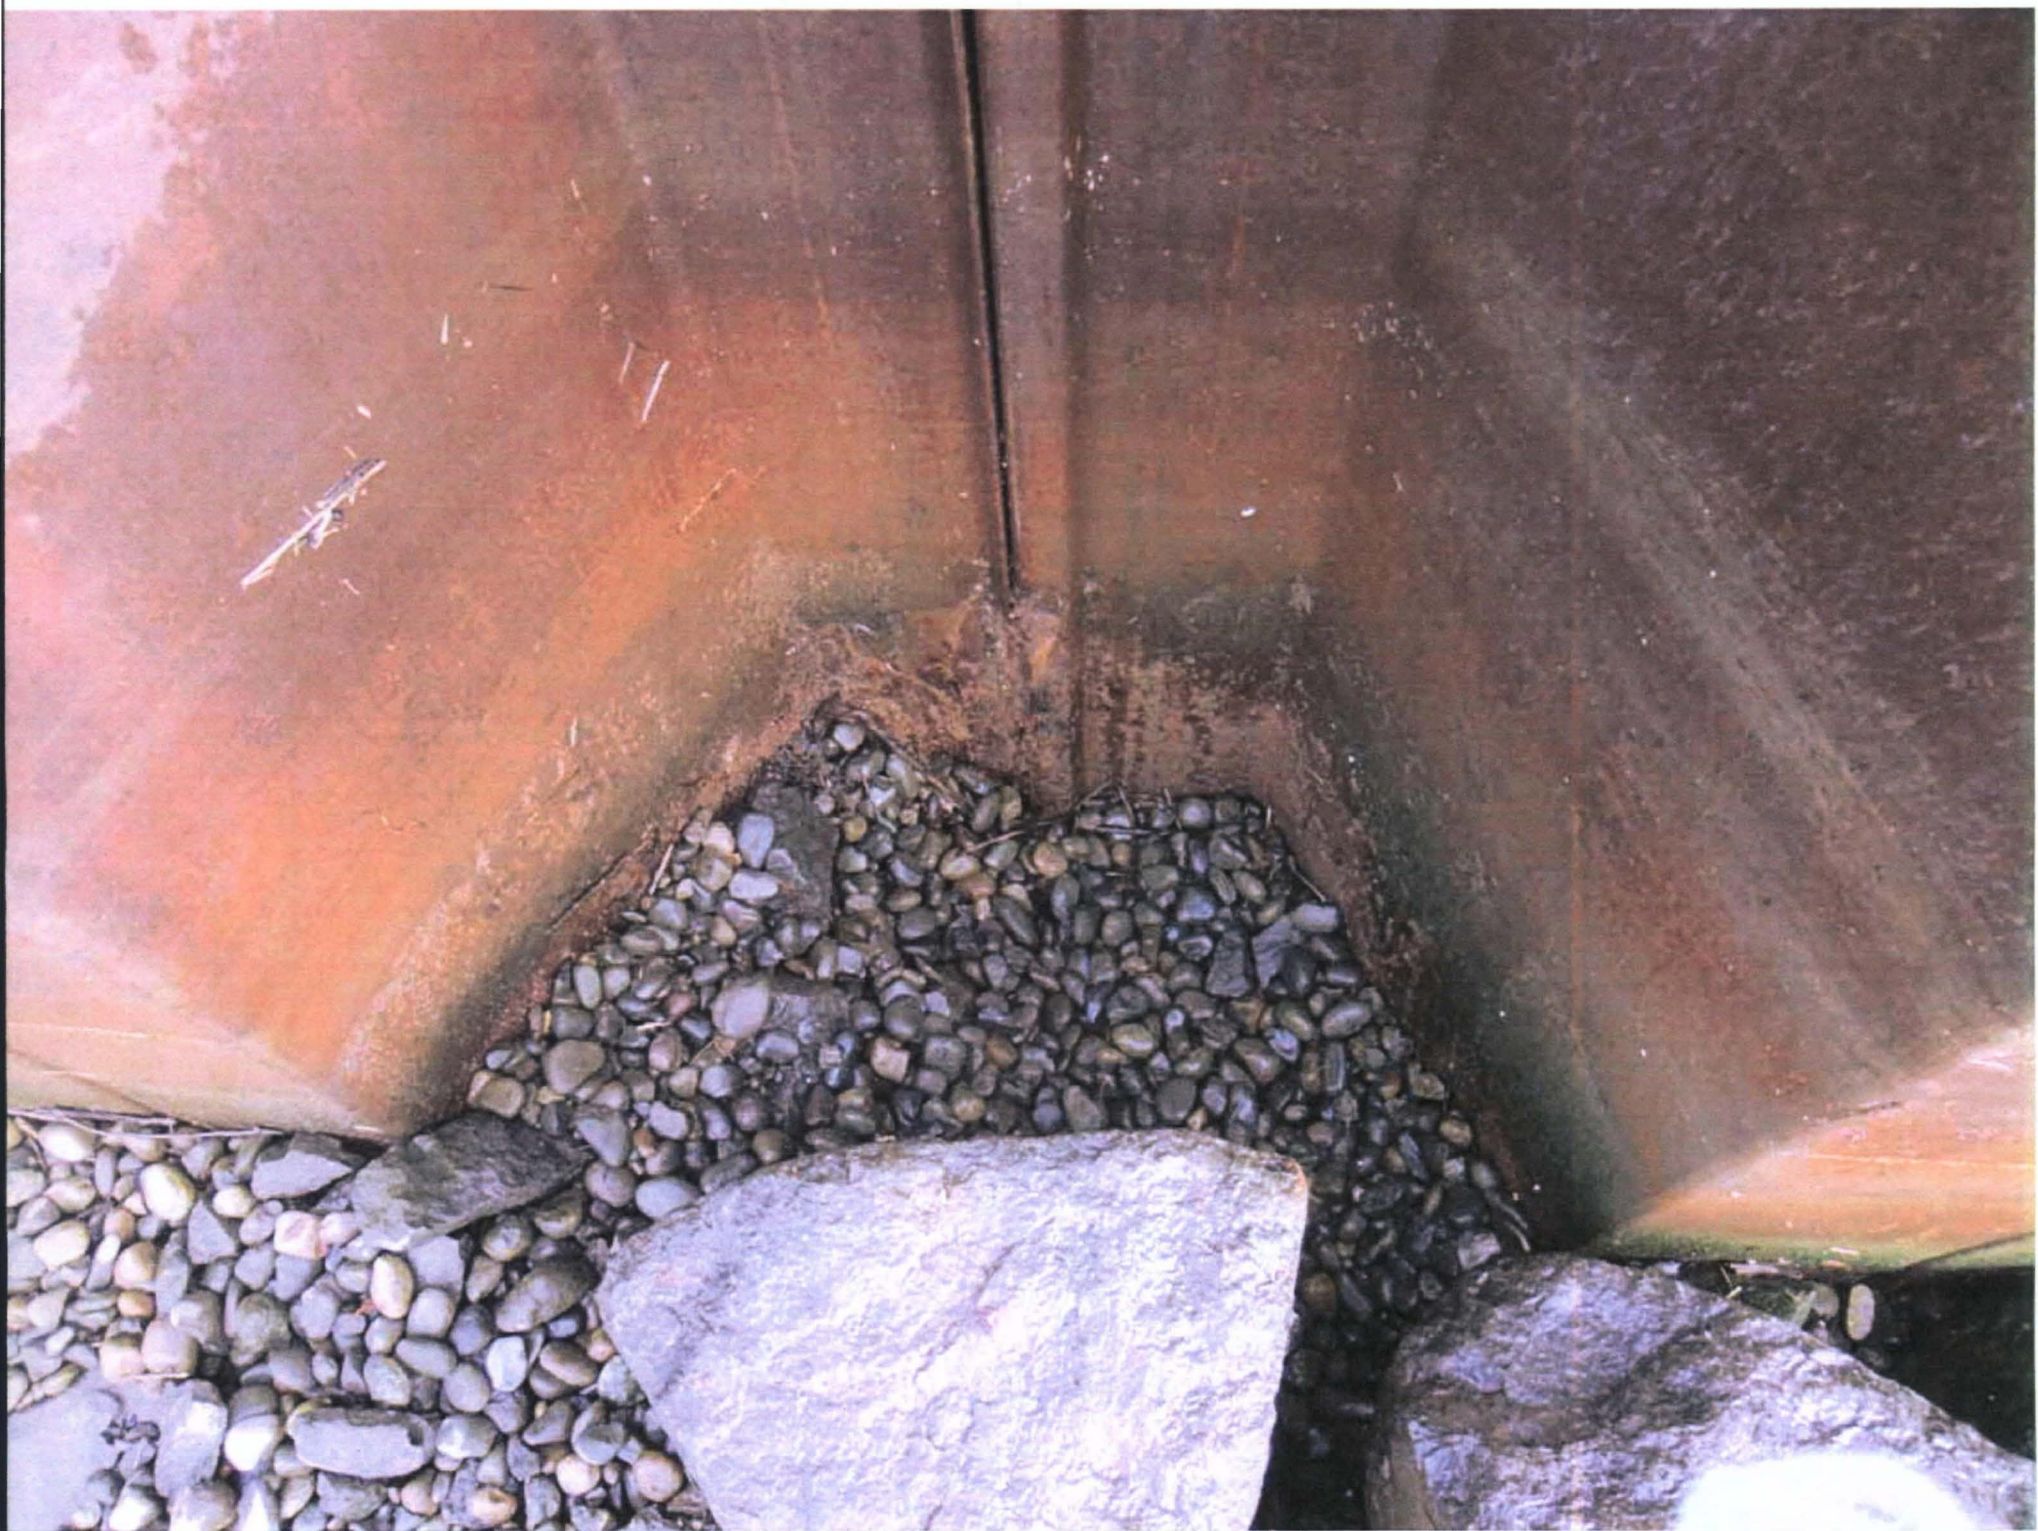
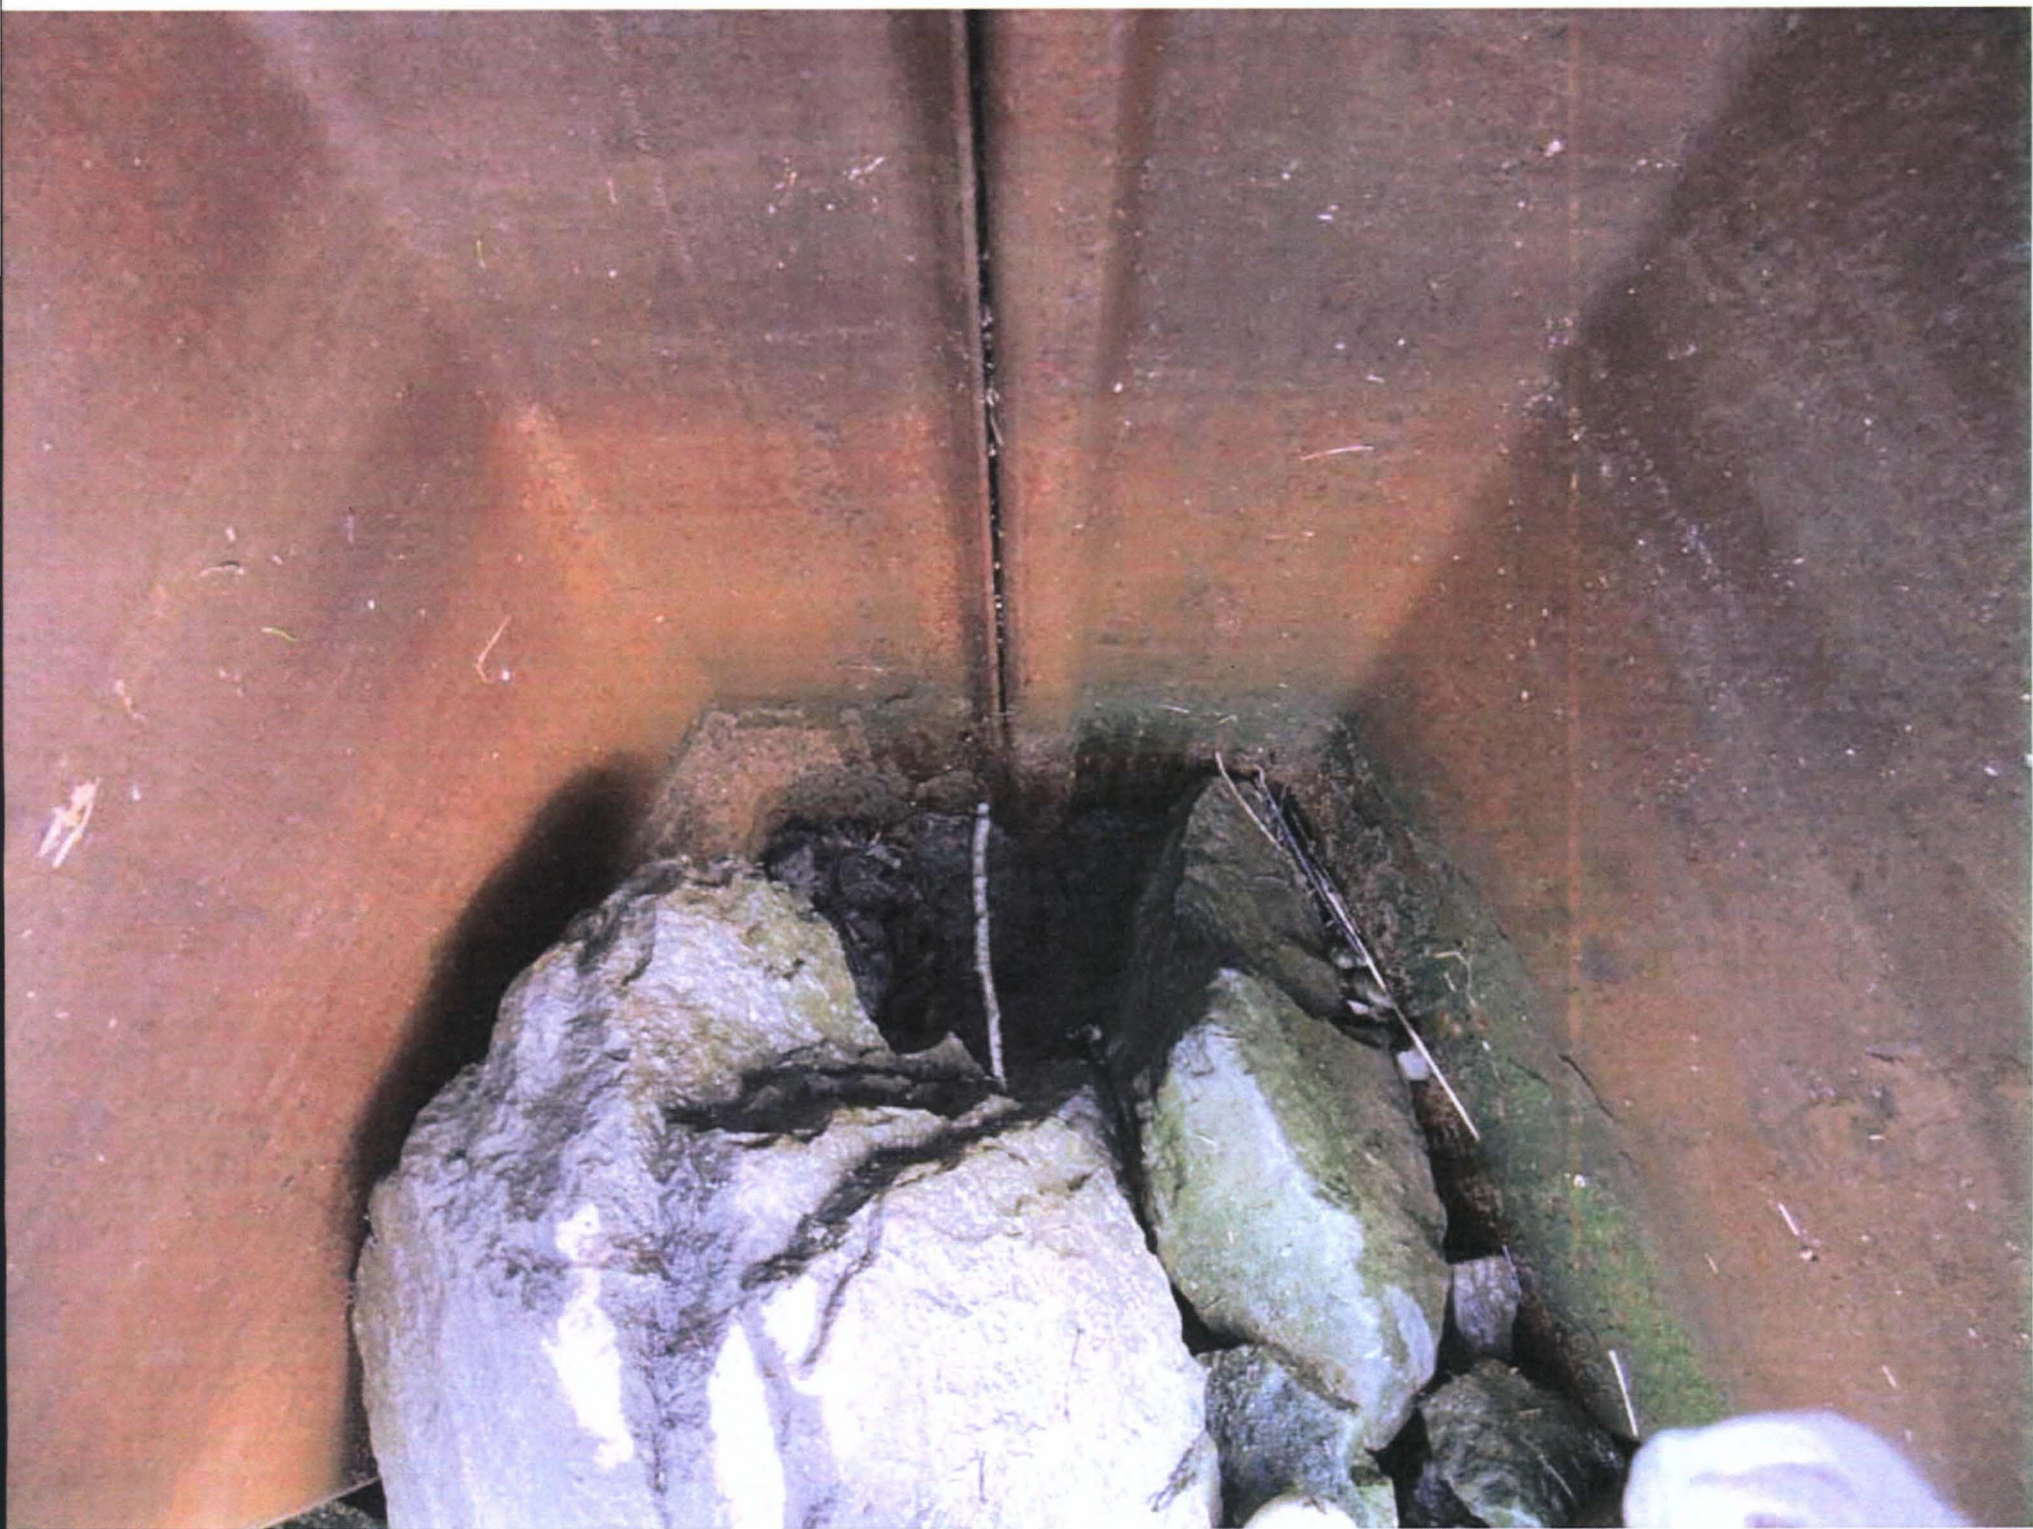
Probing the soil at the outboard face of the SSP wall was completed today during low tide. Miles drove a 3/4 inch rod at the outboard face of the wall at the location of each of the 7 inner interlocks and also at a distance of 6" outboard of the interlock to confirm if rip rap or refusal conditions would be encountered at shallow depth during advancement of the Geoprobe. At all 7 recessed faces, the probe was driven to a depth of about 4 feet below the surface at both the face of the wall and 6 inches outboard of the face. In all instances, the probe advancement was not stopped by rip rap. At two locations, larger rip rap was moved to provide better access. Notes of the probing were recorded by Will. The probing rod was decontaminated with Captur between each probe location and after completing the final probe. A representative of the COE (Jake) was present to observe the work. Based on today's efforts, it would appear that the Geoprobe would readily penetrate the surficial cap and reach target depths. Photos of the wall and ground surface conditions are provided in the attached where the images are arranged in a north to south progression.
